Submitted to:
Platte River Power Authority
Ft. Collins, CO

Submitted by:
AECOM
Denver, Colorado
60699264
January 17, 2023

Platte River Power Authority
Rawhide Station

Annual Ash Monofill Inspection Report – January 2023

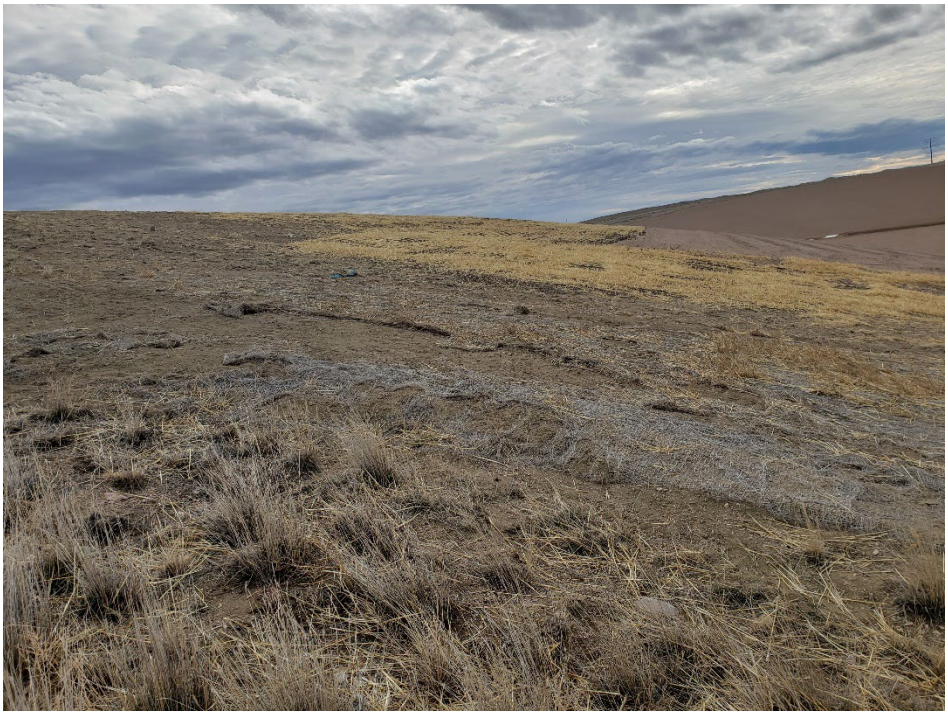
Photo #9 Former repair area of Cell #1 west side, sparse vegetation cover, looking south

- Sparse vegetation and newly seeded areas associated with construction of Cell 2 were observed along the west slope of Cell 1. These areas should be monitored to ensure that vegetation growth is occurring in the spring and summer and that the sparsely vegetated areas are not expanding over time or reseeding may be recommended.

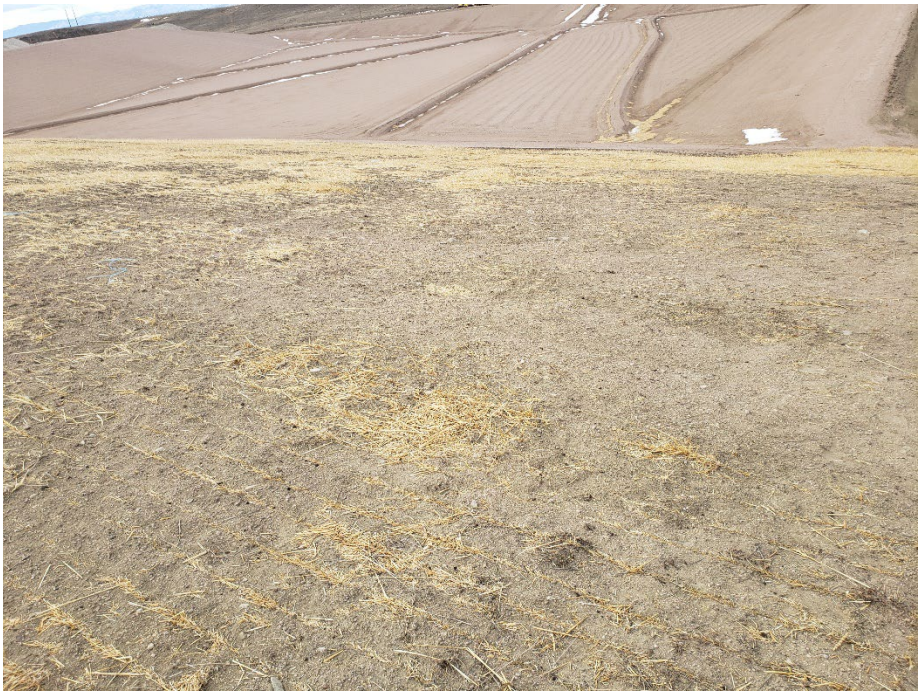
Photo #10 revegetation area cell #1, west side near cell #2 construction area. sparse vegetation looking west towards cells #2 liner installation.
